UNITED STATES ENVIRONMENTAL PROTECTION AGENCY

DATE: APR. 22 1982

SUBJECT: SP Oliver Yard (former Olin Site), Houston, Texas TX01538

FROM: Dennis Guild, Environmental Engineer 76
Enforcement Section

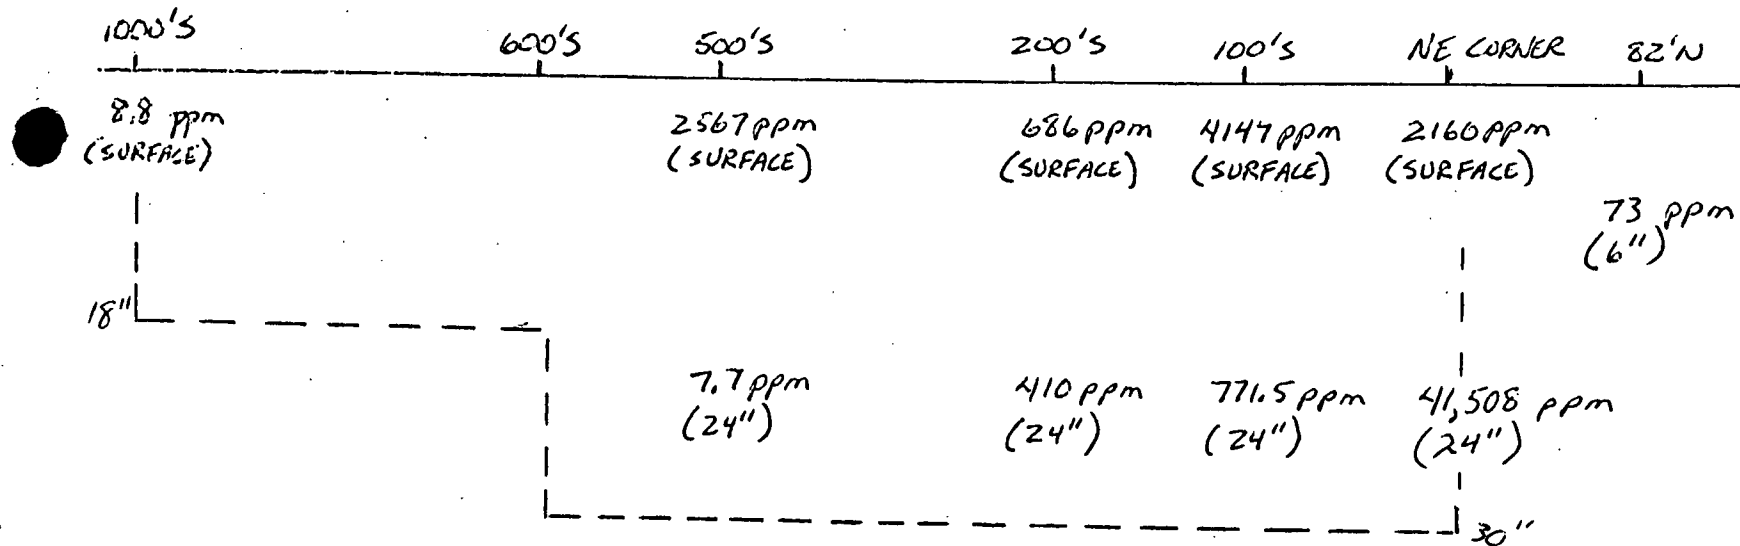
FIGURE 1.

1. According to recent sampling, the most contaminated area of the site is the north - south ditch along its eastern edge. Pesticide levels there range up to 41,508 ppm.
2. A drainage area along the northeastern side of the site (running in an east-west direction) is also heavily contaminated, one sample showing a pesticide concentration of 1490 ppm.
3. The area of the drainage ditch upstream of the site and upstream of the ditch mentioned in 2.II.1 above is also somewhat contaminated, one sample showing a pesticide concentration of 73 ppm.

1. Olin Chemical has submitted a draft Remedial Action Plan to EPA, and it provides, among other things, for removal of contaminated materials from the north-south drainage ditch at the east side of the plant, and replacement with clean compacted clay. Their proposal calls for removal of 2.5 feet in depth along 600 feet of the most contaminated portion of the ditch, and removal of 1.5 feet in depth along the remaining 500 feet of the ditch. The distance dimensions of their proposal (along the length of the ditch), seem adequate, but the proposed depth of removal will doubtlessly leave some contaminated materials behind in certain places (see Figure 1). In the most contaminated area, for example, a sample at 24" revealed at pesticide level of 41,508 ppm, and only 30" are proposed to be removed there.

CROSS SECTION OF DITCH ON EAST SIDE OF S.P. OLIVER YARD

CONCENTRATIONS ARE TOTAL PESTICIDE CONCENTRATIONS IN PARTS PER MILLION

DASHED LINES INDICATE REMOVAL PROPOSED BY OLIN

c. A middle-of-the-road approach is to allow Olin to carry out their plan as proposed, with one additional item: that in the most contaminated area, they also remove and replace any visibly contaminated materials. This option would require Olin to remove the bulk of remaining contamination without giving them the burden and expense of additional sampling and analysis.

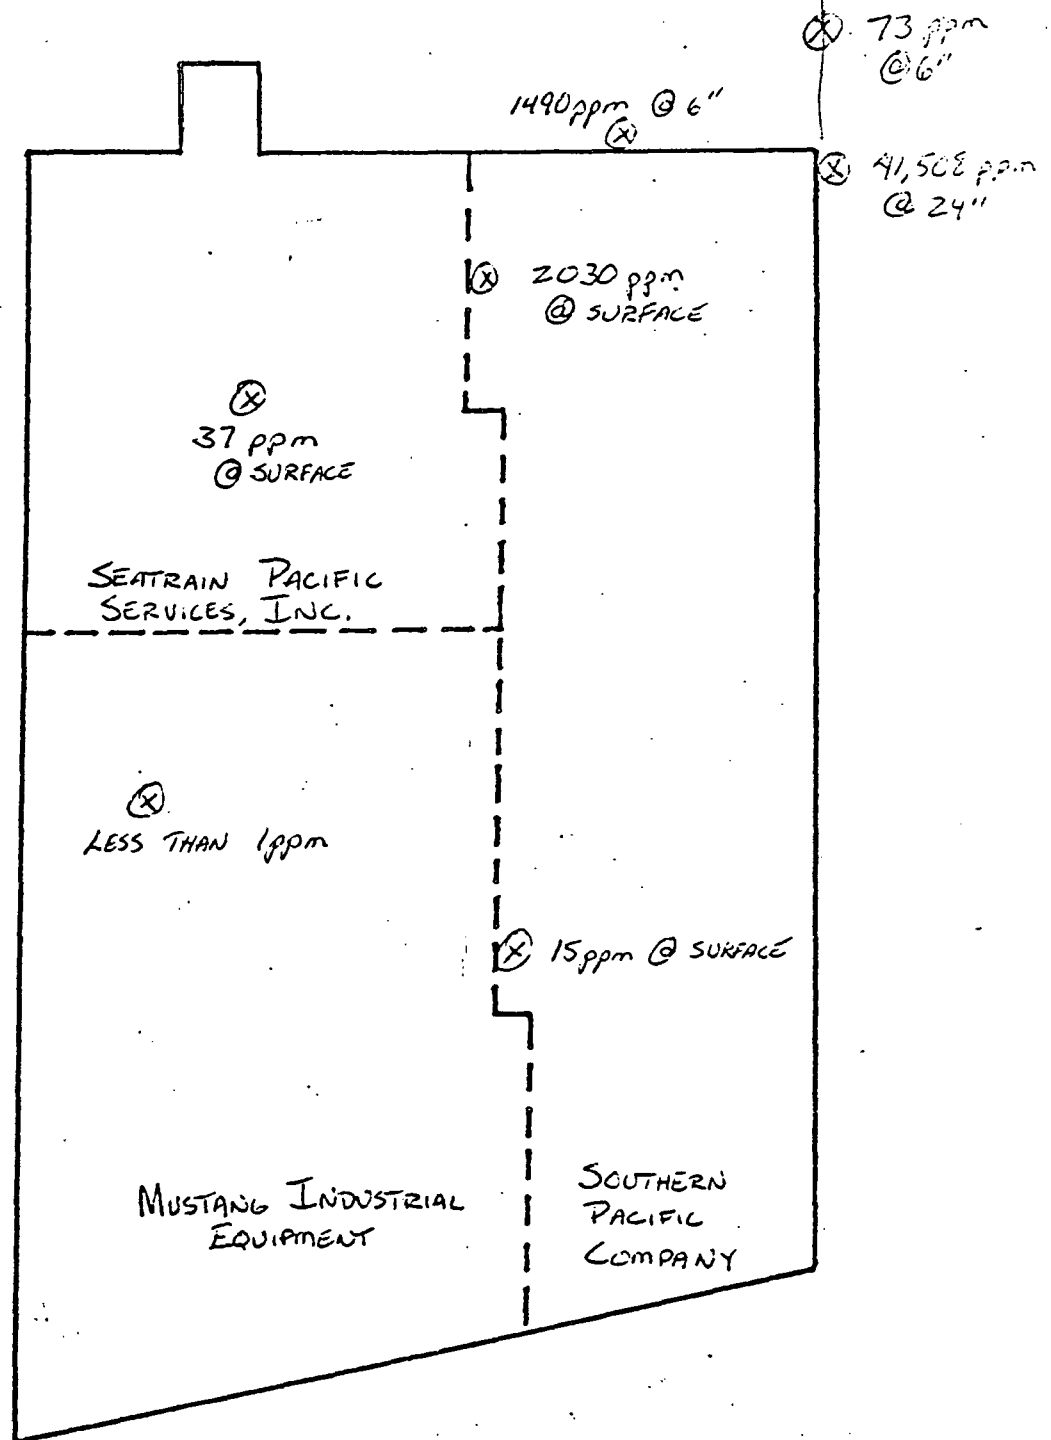
FIGURE 2.
FORMER OLIN PLANT SITE
7621 WALLISVILLE ROAD
HOUSTON, TEXAS
(ABOVE CONCENTRATIONS ARE FOR TOTAL PESTICIDES)

4. The on-site area with the largest detected pesticide level is the northern sector of the Southern Pacific section of the site. A surface sample here showed pesticide of 2030 ppm. Samples acquired at 24" and 48" depth from the same location however, indicated pesticides of less than 1.0 ppm.

5. The surface of the Seatrain lot (northwestern area of site) is also somewhat contaminated, one surface sample showing a pesticide level of 37.4 ppm. Samples at 24" and 48" from the same location, however, showed pesticides of less than 1.0 ppm.

7. One location from a drainage ditch in the center of the site was sampled, the surface showing 15.0 ppm, and the 24" and 48" depths each showing less than 1.0 ppm.
